TAY BRIDGE DISASTER.

REPORT OF THE COURT OF INQUIRY,

REPORT OF MR. ROTHERY,

Circumstances attending the Fall of a Portion of the Tay Bridge
on the 28th December 1879.

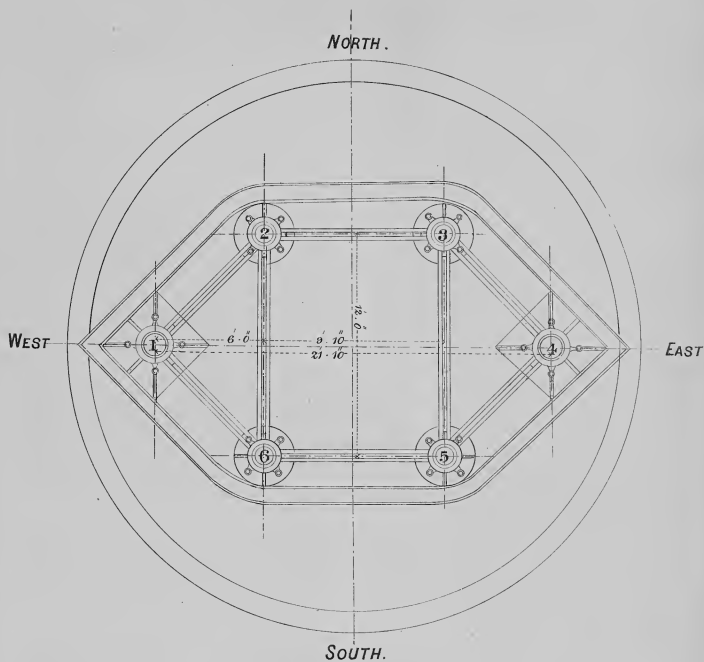
SECTIONAL PLAN OF THE BASE OF ONE OF THE FALLEN PIERS.

(26.) We have said that it was originally intended to build the piers, which supported this part of the structure, of brick; but that, when it was found that the rock had disappeared, it was determined to lighten the piers by making them of cast-iron columns, and at the same time to increase considerably the area of the foundations. To obtain foundations for the piers, wrought-iron caissons 31 feet in diameter were constructed on the shore, which, on being lined with 18 inches of brickwork were floated out, and sunk in their proper places. This was an extremely difficult operation, but appears to have been successfully performed. After a caisson had been sunk as low as was deemed necessary, the centre was filled up with concrete; and upon this was built a hexagonal-shaped pier, measuring 27 feet 6 inches from east to west, and 15 feet 6 inches from north to south; the lower part of which was faced with brick, whilst the four upper courses were faced with stone, the centre, as in the case of the caissons, being filled with concrete. And at the angles of the hexagonal pier were placed six cast-iron base pieces, 2 feet in height, and secured to the pier by holding-down bolts passing through the two upper courses of stone; and upon these were raised the columns. The arrangement of the foundations, the pier, and the base pieces will be best seen from the plan annexed to this Report, which is taken from a drawing in Mr. Law's report. *The foundations. Vide plan annexed.*
